A Survey of the Rural Resources of Crittenden and Livingston Counties, Kentucky

**Kentucky Archaeological Survey
Jointly Administered By:
The University of Kentucky
The Kentucky Heritage Council
Report No. 214**

KAS Report No. 214

February 2012

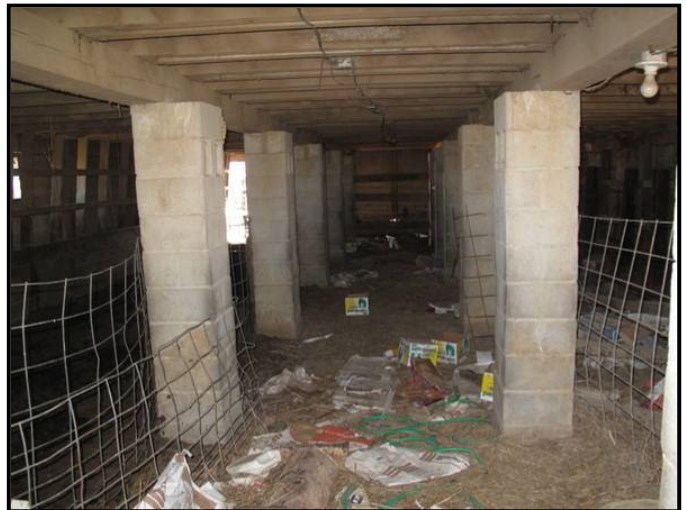
Figure 3. 30 *Interior of the concrete block barn, CN-32, at the O.B. McDaniels Farm.*

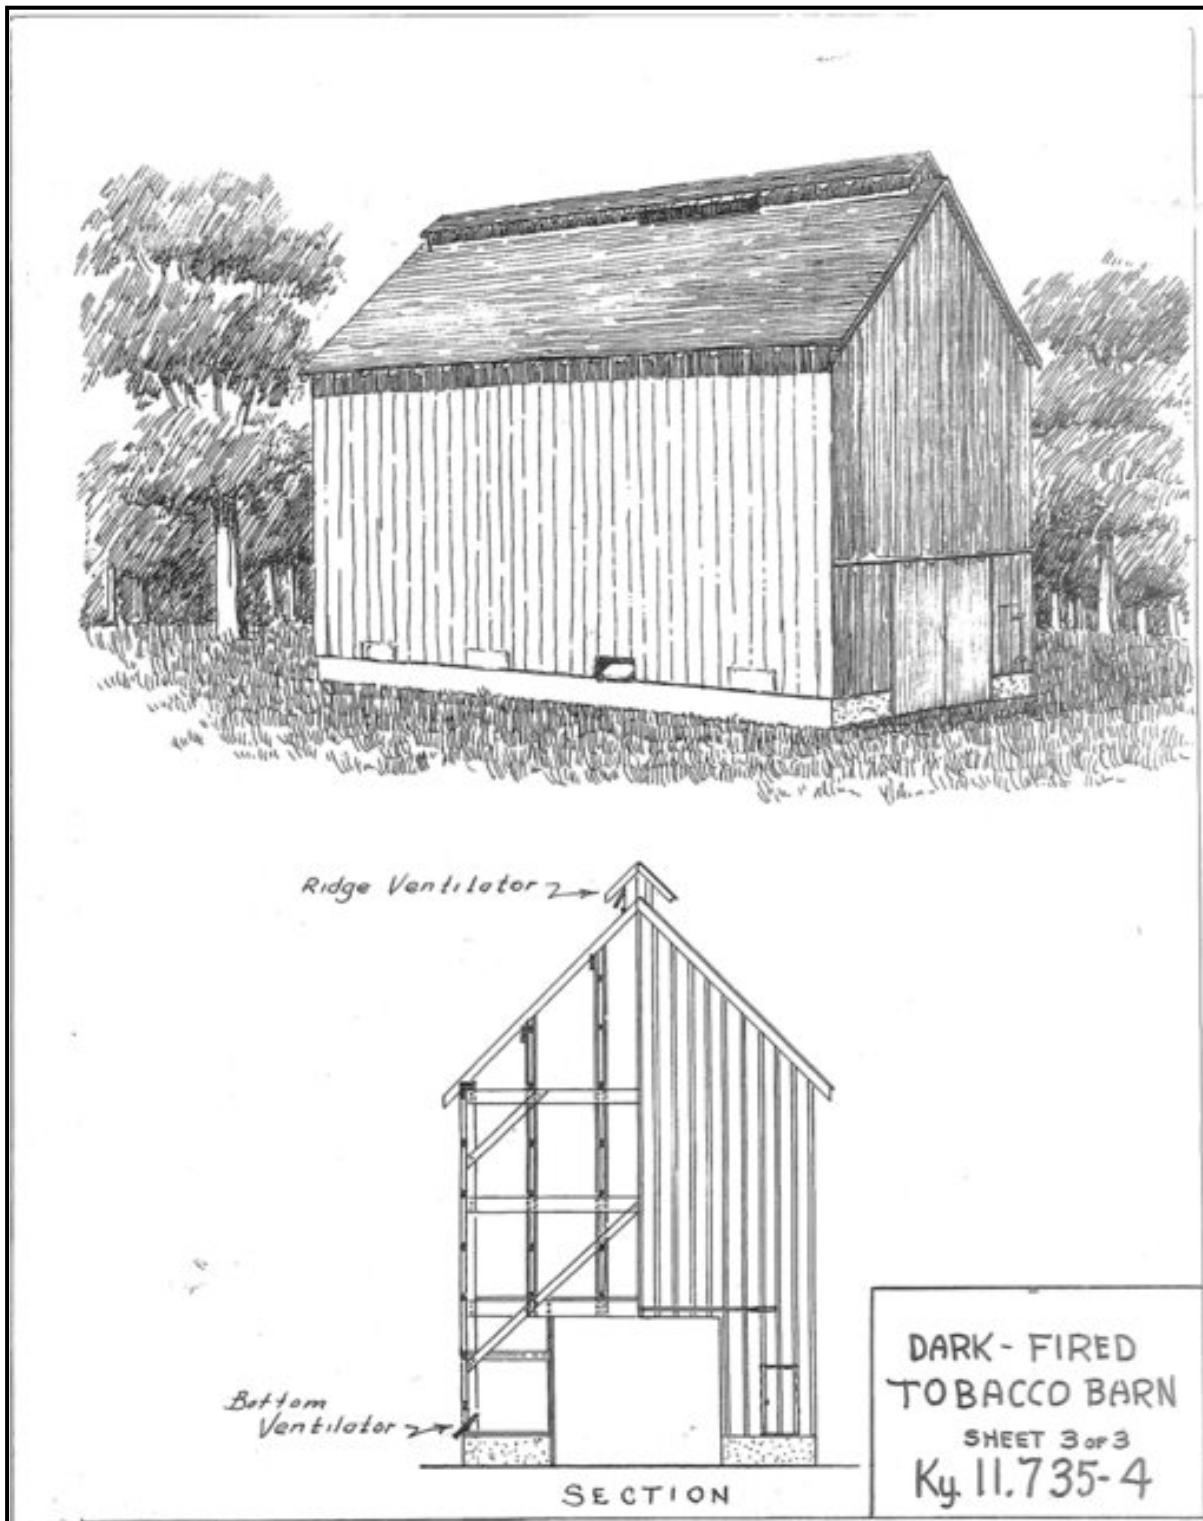
Figure 3. 51 Dark-fired tobacco barn plan, developed by Agricultural Engineering, University of Kentucky College of Agriculture, May 1, 1926. Plan provided courtesy Dr. George Duncan, Extension Professor Emeritus, College of Agriculture Biosystems and Agricultural Engineering.

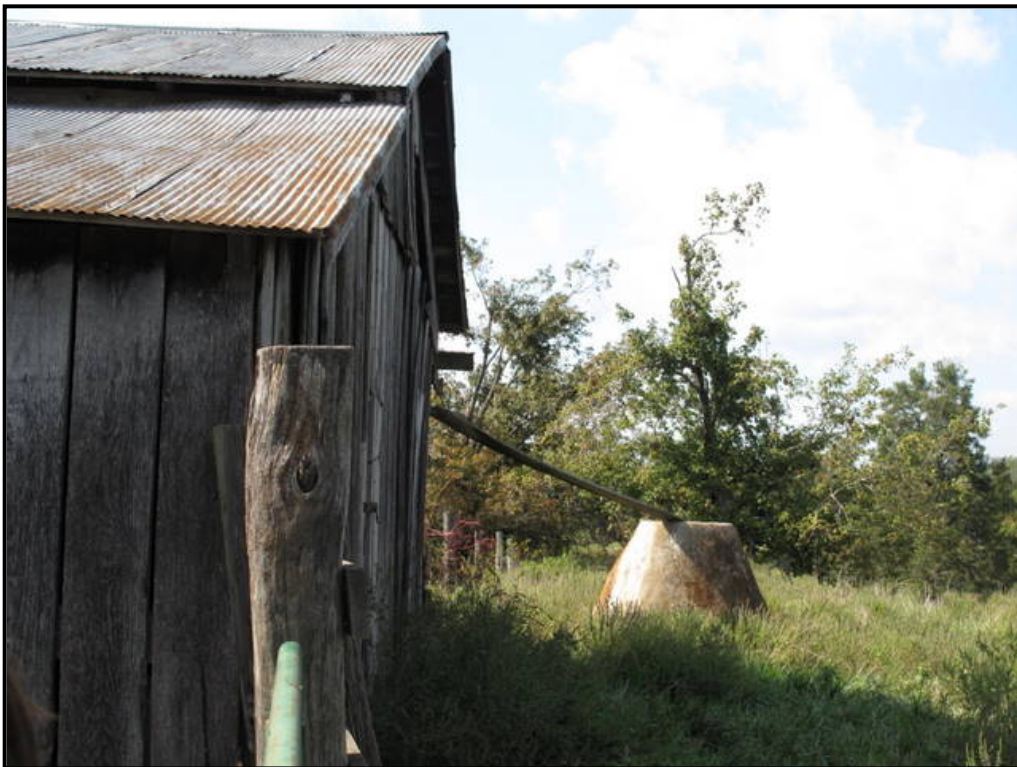
Raised conical cisterns, often brick covered with a veneer of poured concrete, were identified at several sites in the two counties. These cisterns collected water from gutters (CN-67, Figure 4.30) collects water off of the barn roof) on houses and outbuildings. The water then flowed through an underground pipe, either by gravity or through a pump, to its desired location. Farms might have multiple cisterns to collect and store water, and complicated system of piping and pumping to deliver the water. The most efficient way to deliver the water from the cistern was a pump at the cistern itself, since it is easier to push rather than pull water to its desired location.

Figure 4. 30 *Raised cistern in barn lot at CN-67.*

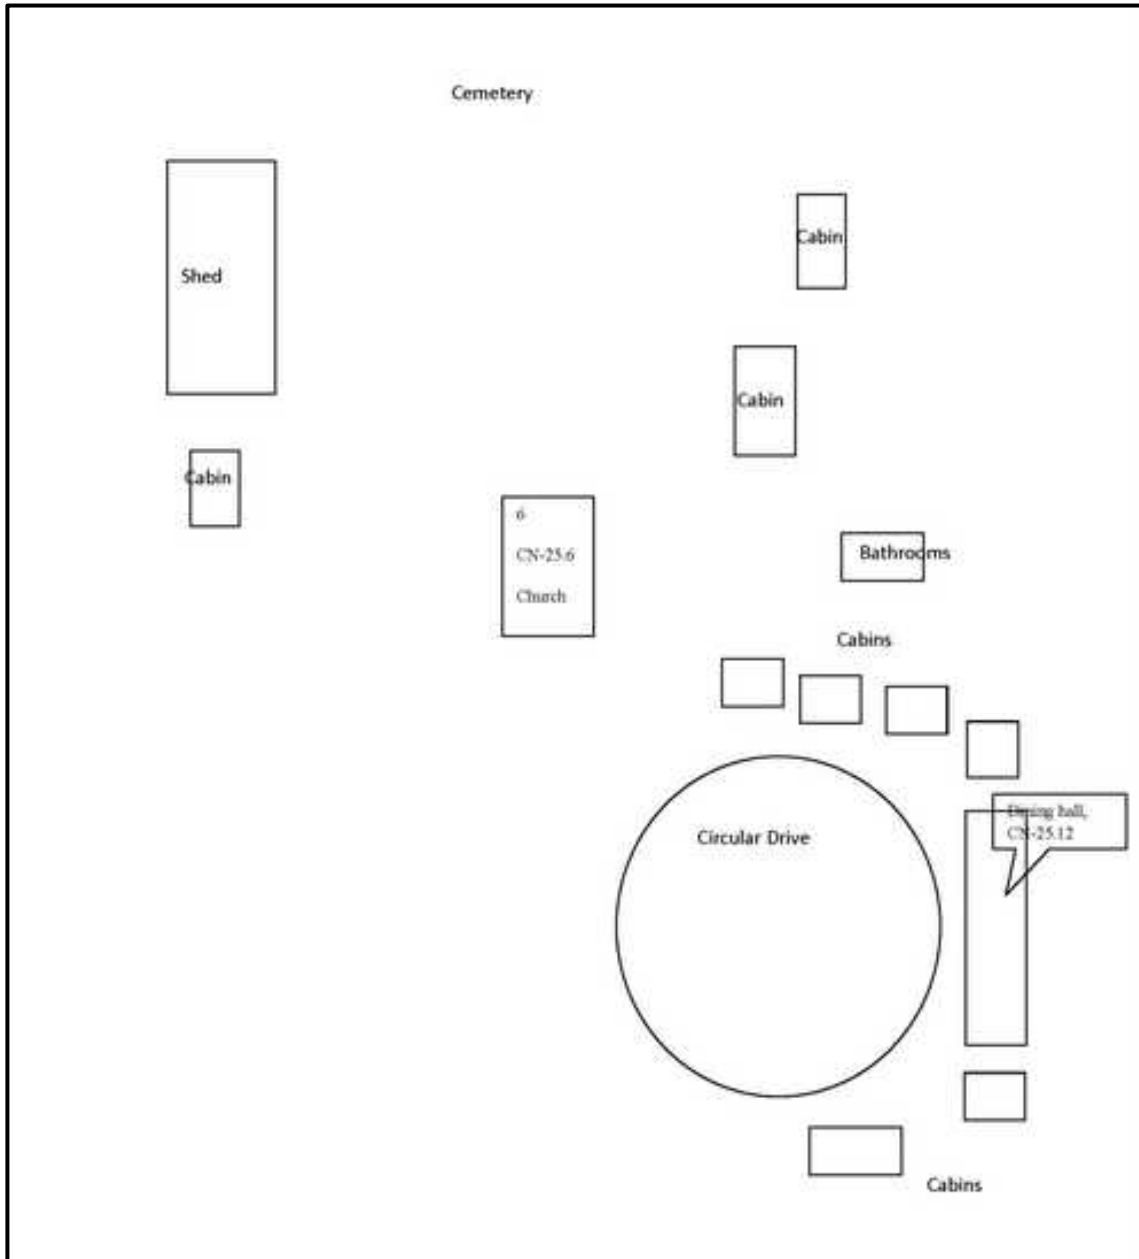
Figure 5. 38 Site plan of Hurricane Camp Meeting Ground (CN-25).

Hurricane Camp, organized in 1889, is located in northern Crittenden County near Tolu. Though the meeting dates to the late-nineteenth century, Hurricane Church was established in 1843. The meeting grounds are extensive (Figure 5.38). The camp, still operating each summer, has a very large shed (Figures 5.39 and 5.40) and church (Figure 5.41) both of which date to around 1920, built to replace earlier structures that burned. Frame and concrete block cabins (Figure 5.42) for camp attendees, a dining hall and a large cemetery complete the site.
