The Rural Landscape of Casey County: Farms and Crossroad Communities

Kentucky Archaeological Survey
Jointly Administered By:
The University of Kentucky
The Kentucky Heritage Council
Report No. 213

July 2011

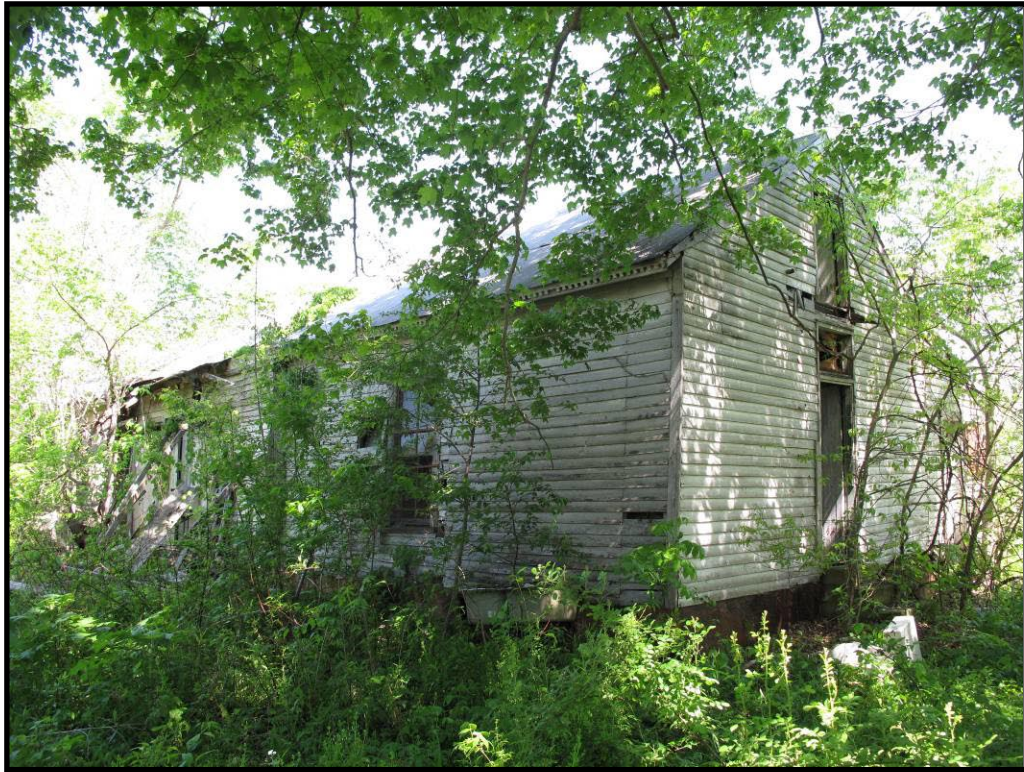
Figure 74 *West and south elevations of the Powers/Peyton's Store, CS-84.*

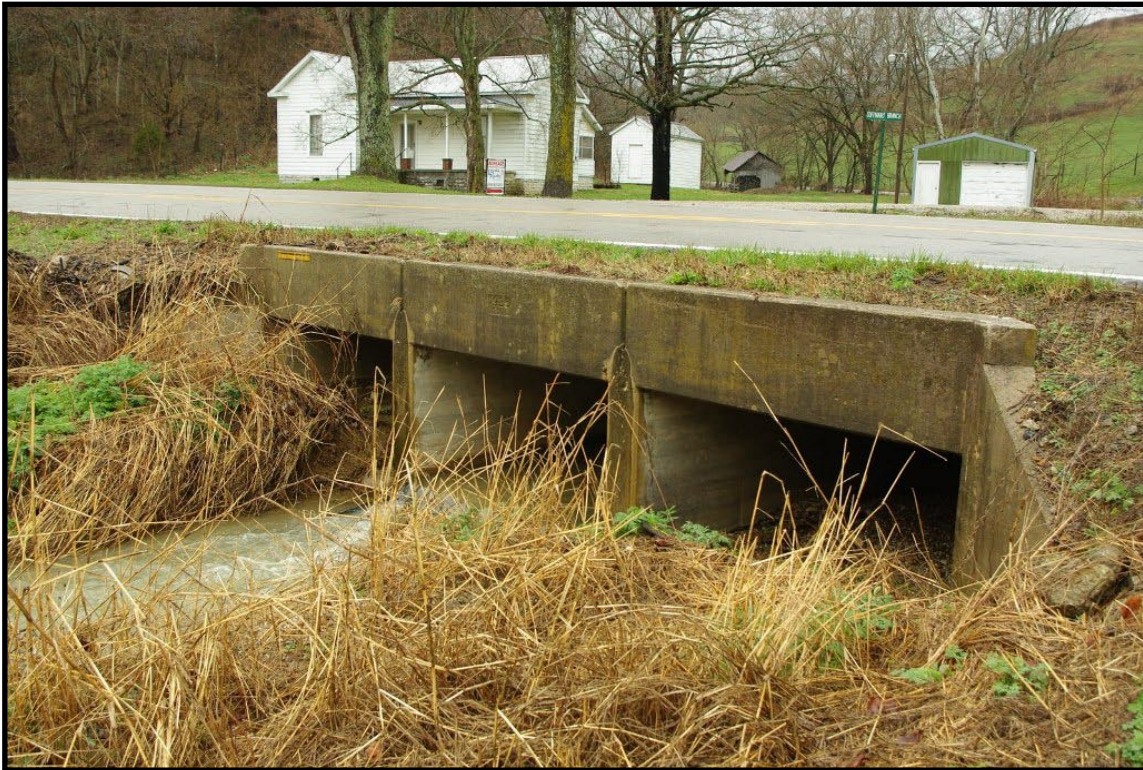
Figure 80 CS-87, a WPA-era culvert (1935) in the Ellisburg quad.

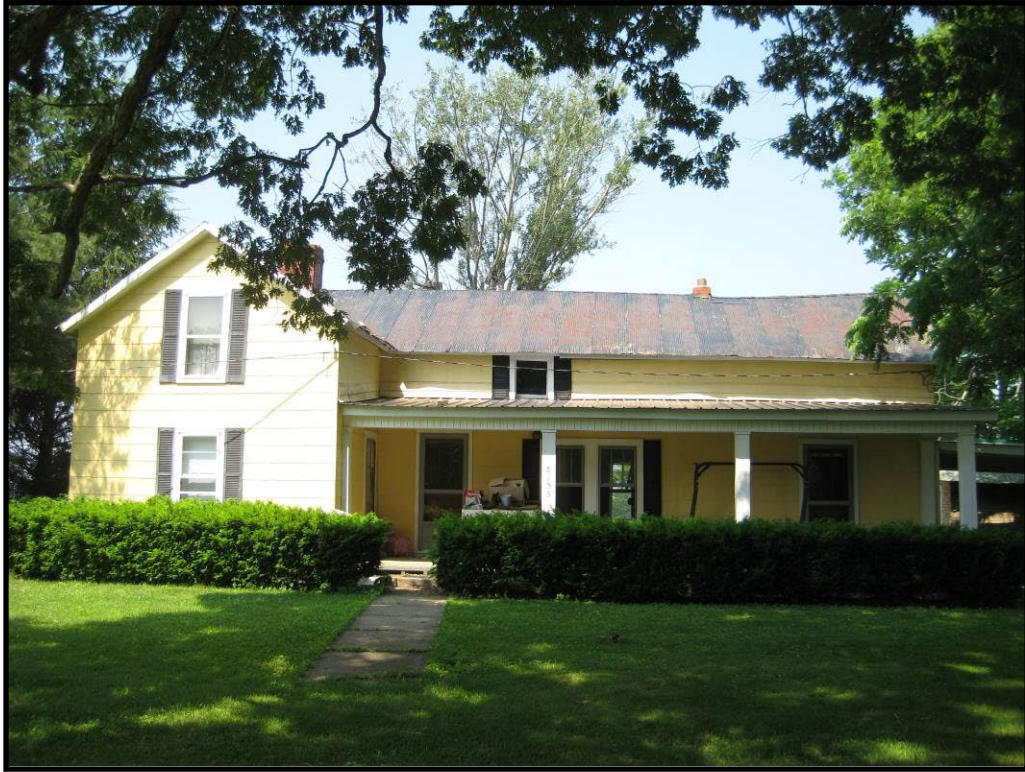
Figure 90 *Façade of CS-121, Eubank quad, which appears to be a log saddlebag with a frame front gable addition.*

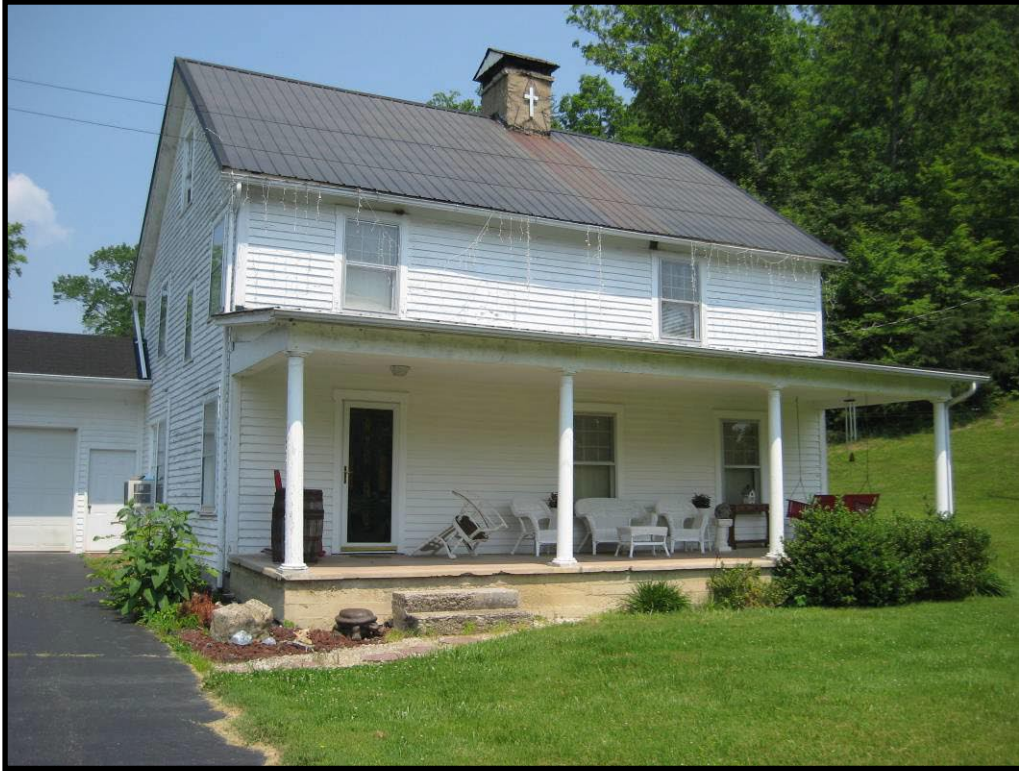
The side-passage plan, as it evolved in Kentucky, is primarily an urban type, dictated by the constraints of narrow urban lots and the combination of businesses with living space. The Philadelphia house, found both in its namesake city, and in urban centers across the mid-Atlantic, could serve as a model for the urban side-passage plan in Kentucky.⁵³ Many side-passage plans had a business on the ground floor and the living space and family quarters on the second floor. The side-passage still allowed the occupants to control the passage of visitors. The ease of this plan adapting to both commercial and residential use would explain its popularity within town centers.

Figure 91 *Façade of CS-104, a possible side passage on KY 501, Yosemite quad.*

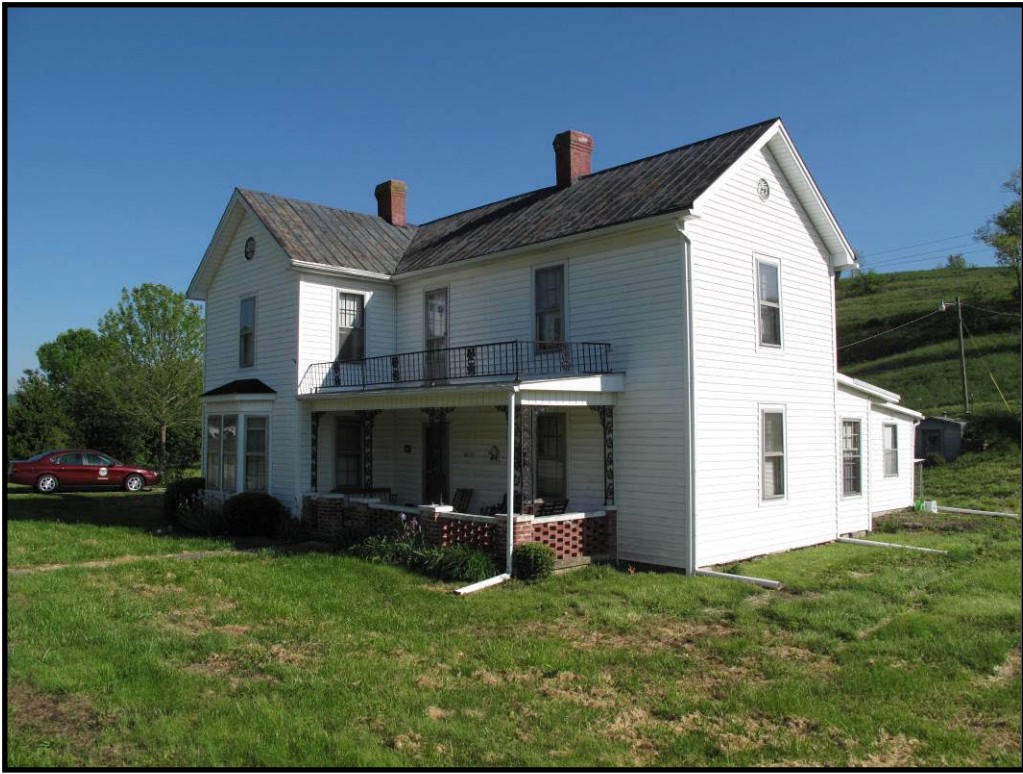
The late nineteenth century saw an increase in frame construction, largely due to the introduction of balloon framing. The ease and affordability of this construction method allowed standard rectangular and square forms to be modified. T-plans and cross-plan houses became common, as did the addition of porches and decorative elements on a common house forms. The T-plan is a variation on the I-house – one of the rooms located along the central hall was moved forward, resulting in an irregular facade. This allowed the rooms in the ell to be accessed by the central passage.

Figure 99 *The William Mills House (CS-78), an 1893 T-plan in Ellisburg.*

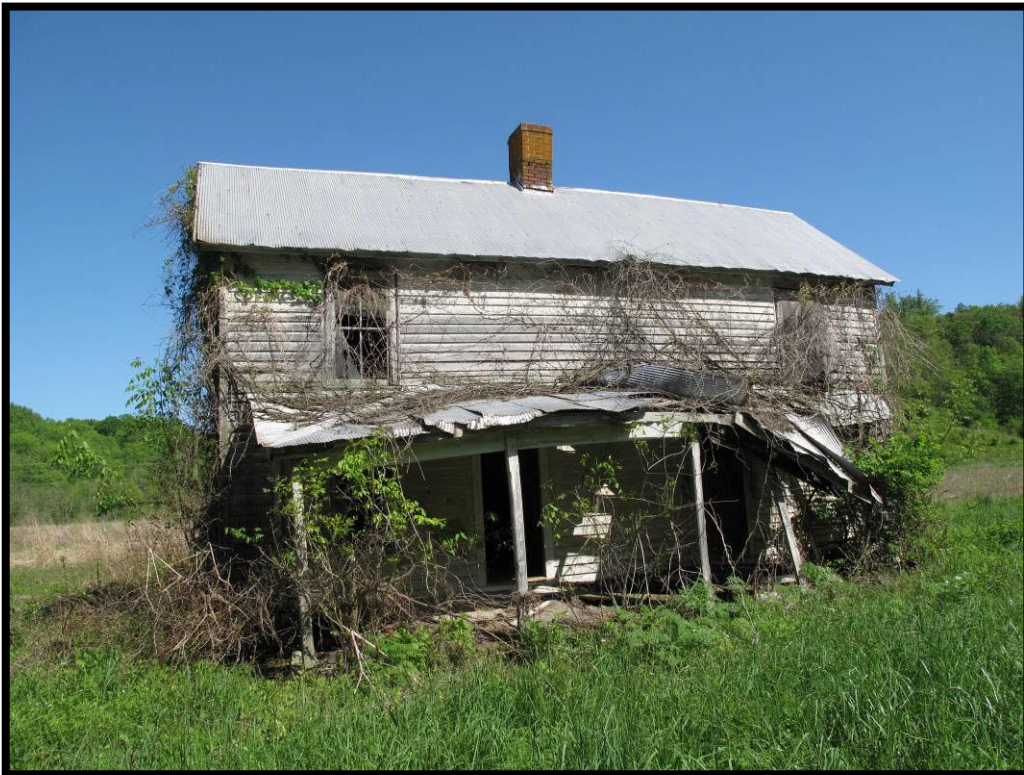
All of the surveyed Cumberland houses were frame, with a window/door/door/window fenestration pattern. All had side-gable oriented roofs, with a central chimney, usually a shed roof front porch and a one-story addition to the rear, usually a gabled roof addition forming an ell from the front portion of the dwelling.

Figure 107 CS-91, an abandoned *Cumberland* on Long Hollow Road, Ellisburg quad.

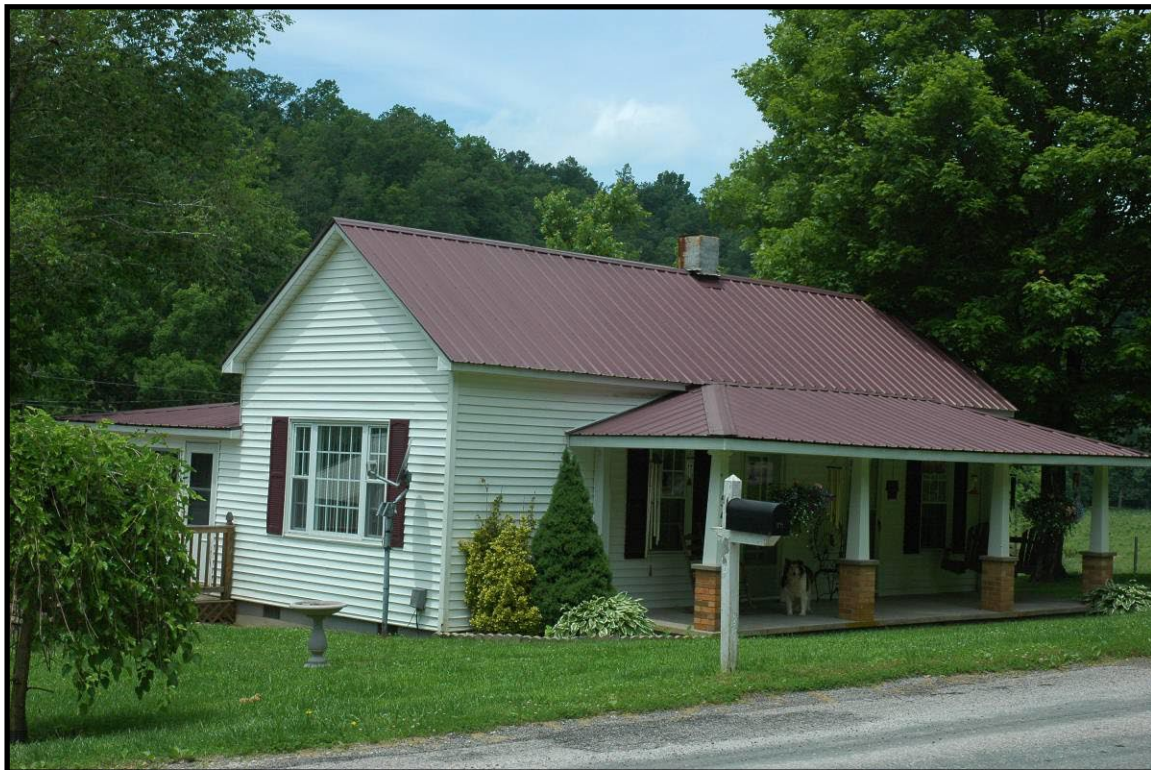
Figure 116 CS-111, 1549 Shucks Creek Road, Ellisburg quad.

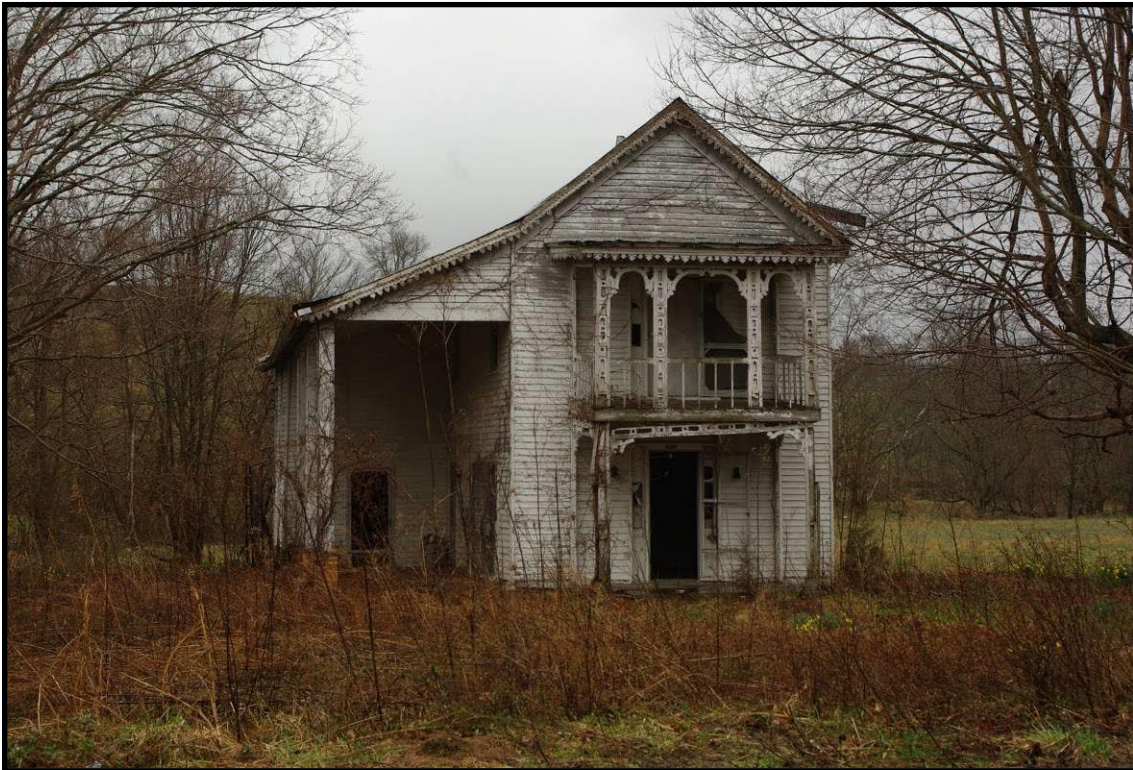
One of the most intriguing dwellings surveyed was also in Peyton's Store, a two-story, front-gable frame dwelling (CS-85) that appears to be a single room plan with a side addition (Figure 131 and 133). The house features intricate details, including the elaborate bargeboard and trim on the two-story porch (Figure 132), and an interior with Greek ear door surround and paneled wainscoting (Figure 134). Sadly, the dwelling is abandoned and in deteriorating condition.

Figure 131 *Façade of CS-85 in Peyton's Store, Ellisburg quad.*

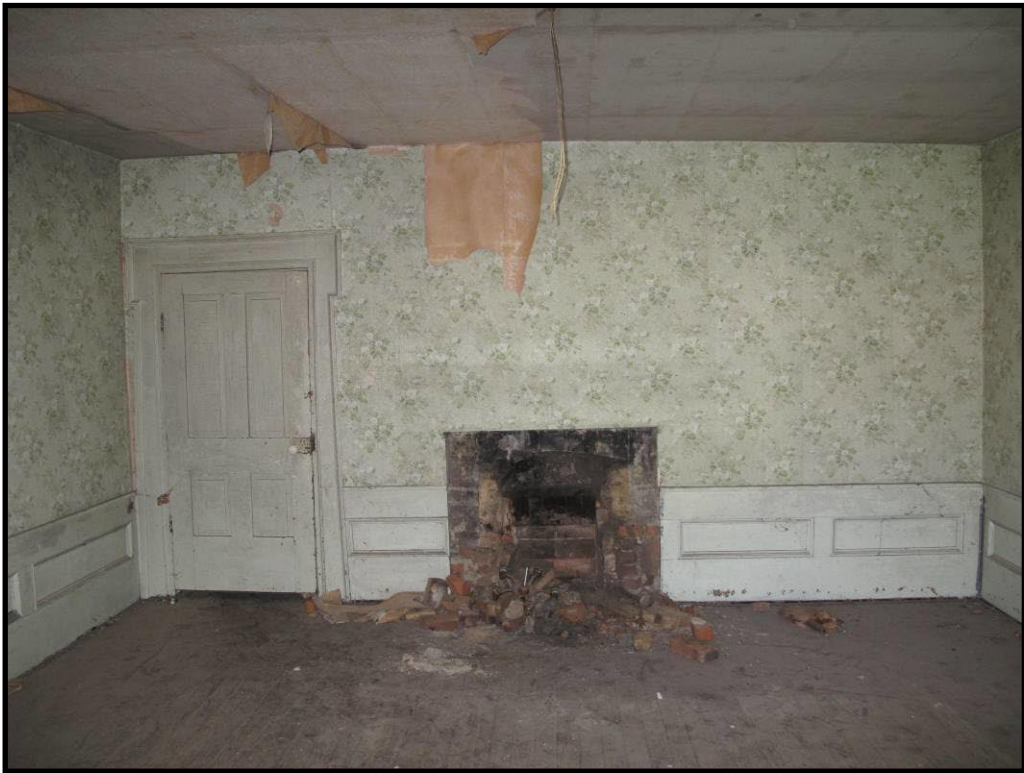
Figure 134 *Interior of CS-85.*

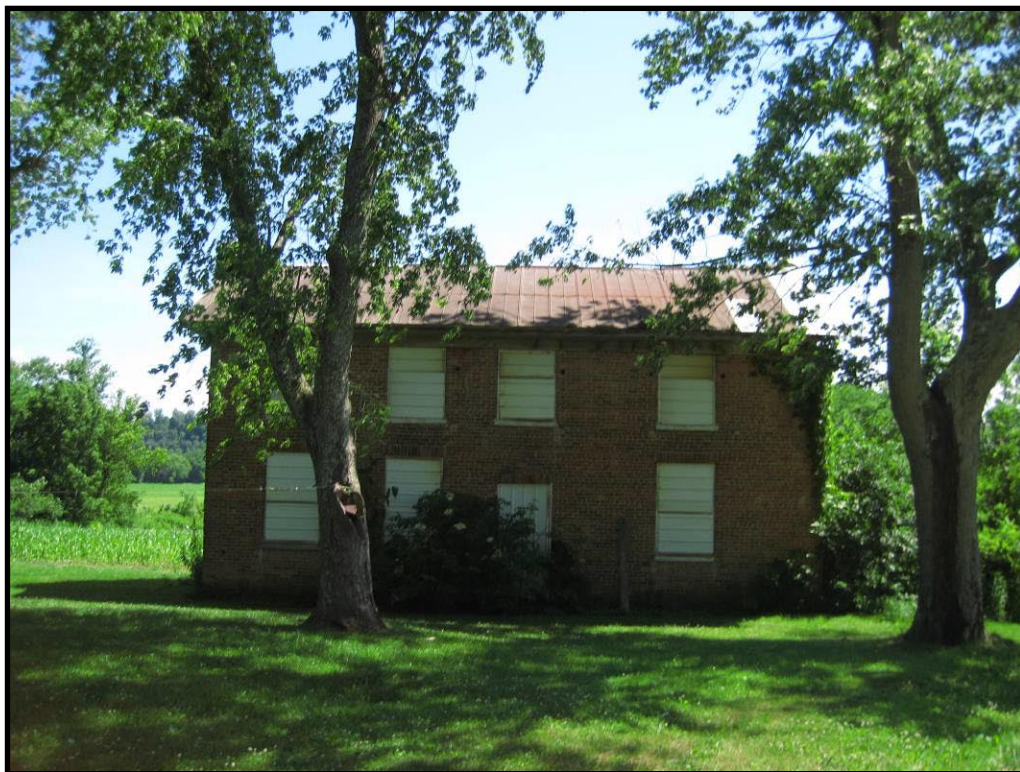
The one masonry dwelling surveyed as part of this project was a boarded-up, two-story brick house (CS-158) referred to by a local resident as the “second oldest brick house in Casey County.” The house is located in bottom land along the Green River in the Phil quadrangle, and was reportedly built by the first sheriff of Casey County, Benjamin Dawson. It was later referred to as the “brick house farm” in historic documents and was owned by James Richard Dunn, whom Dunnville is named after. Built on a continuous stone foundation, the abandoned hall-parlor house is three bricks thick, and four bays wide. There are exterior brick chimneys on either gable end. The fenestration is window/window/door/window; there are simple jackarches above the window and door openings. Despite having a hall-parlor plan (Figure 137), which lends credence to the construction during the first two decades of the nineteenth century, the interior is unabashedly Greek Revival (Figure 136) with Greek ear door surrounds and two-panel vertical doors.

Figure 135 *Dawson/Dunn House, CS-158, Dunnville quad.*

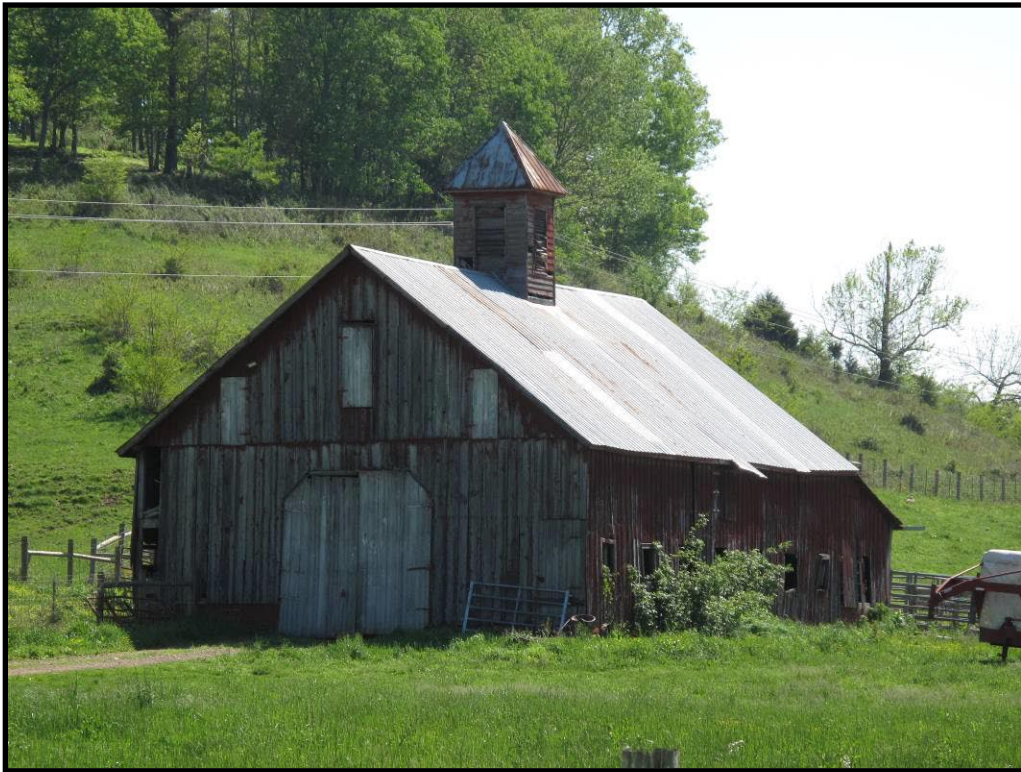
Most of the barns in the project date from the twentieth century and are multi-purpose barns, used to not only house tobacco, but for stock, including cattle and horses. One nineteenth century barn was surveyed, a purpose-built stock barn at CS-80 in the Ellisburg quad (Figures 164-166). The transverse frame barn rests on a stone foundation (concrete block has replaced the stone at one end) and has a metal roof pierced by a cupola with louvered vents. The barn has a bi-level loft and stalls on either side, with grain storage (raised floor) in one stall space on the end, and a tack room at the other, opposite end.

Figure 164 *Nineteenth century stock barn, west gable end and south side, CS-80, Ellisburg quad*

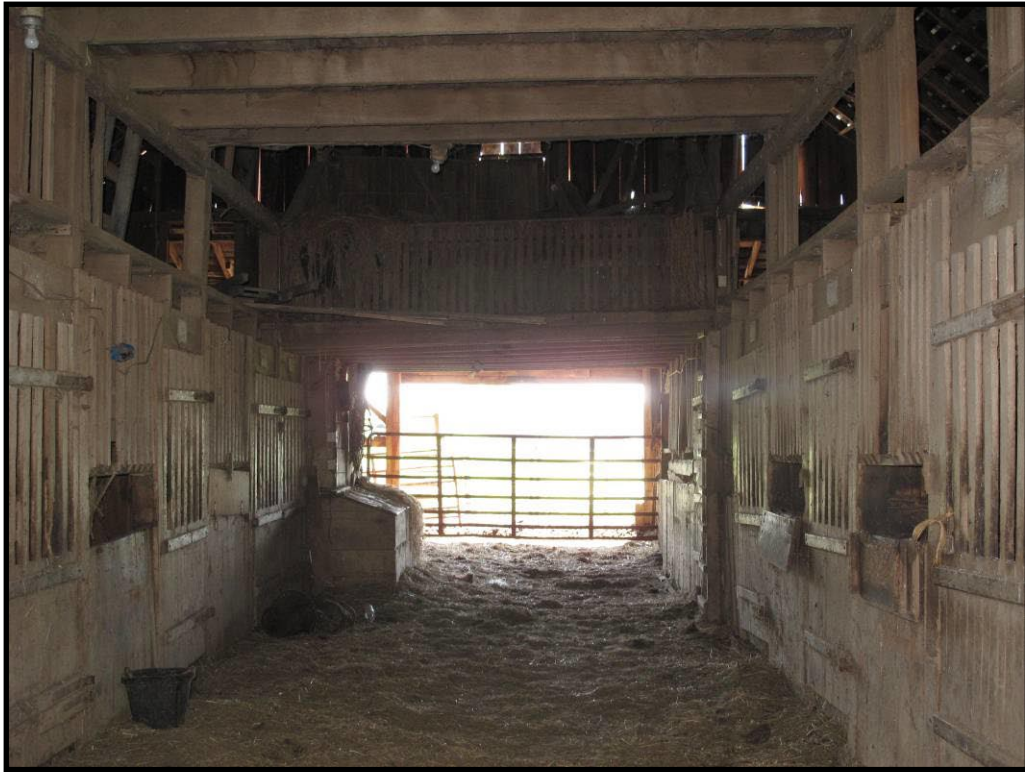
Figure 166 Interior of barn at CS-80, facing east.

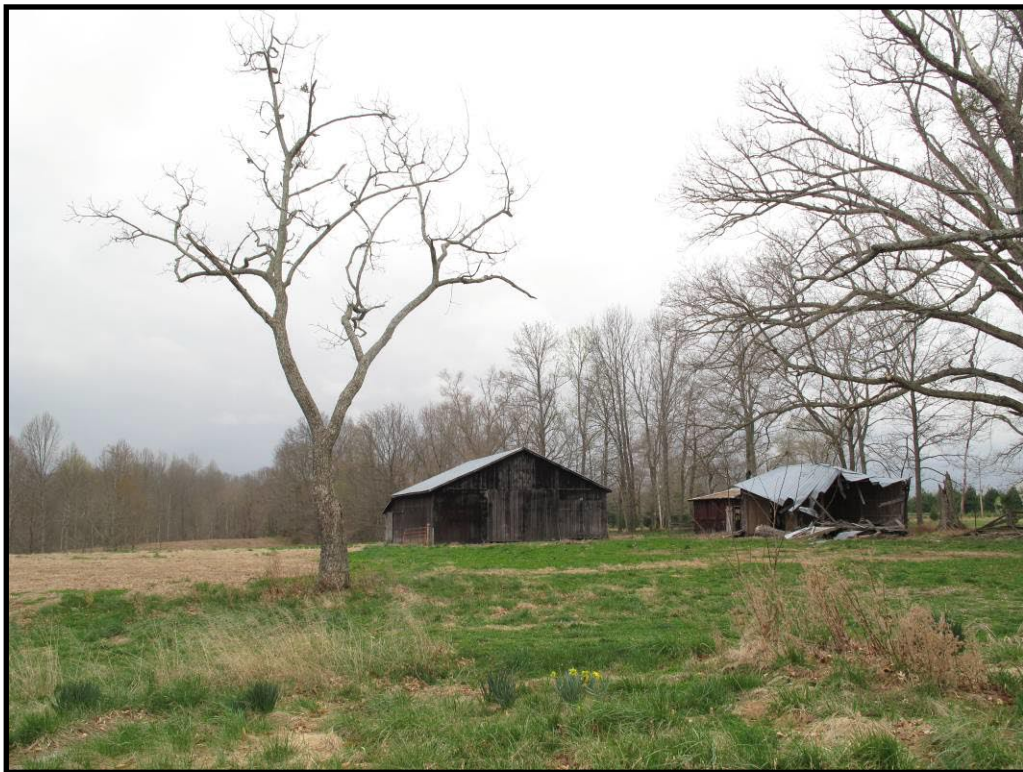
Figure 173 Two barns at CS-58, the one on the left, a newer multi-purpose barn and a dilapidated small stable/stock barn on the right. Clementsville quad.

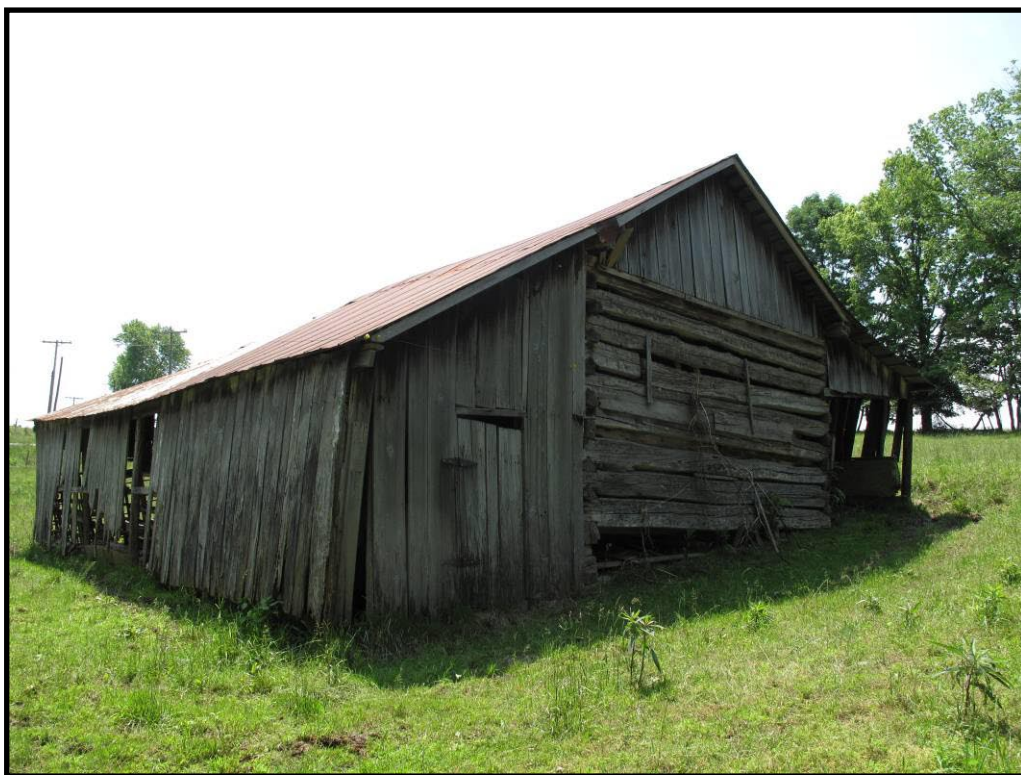
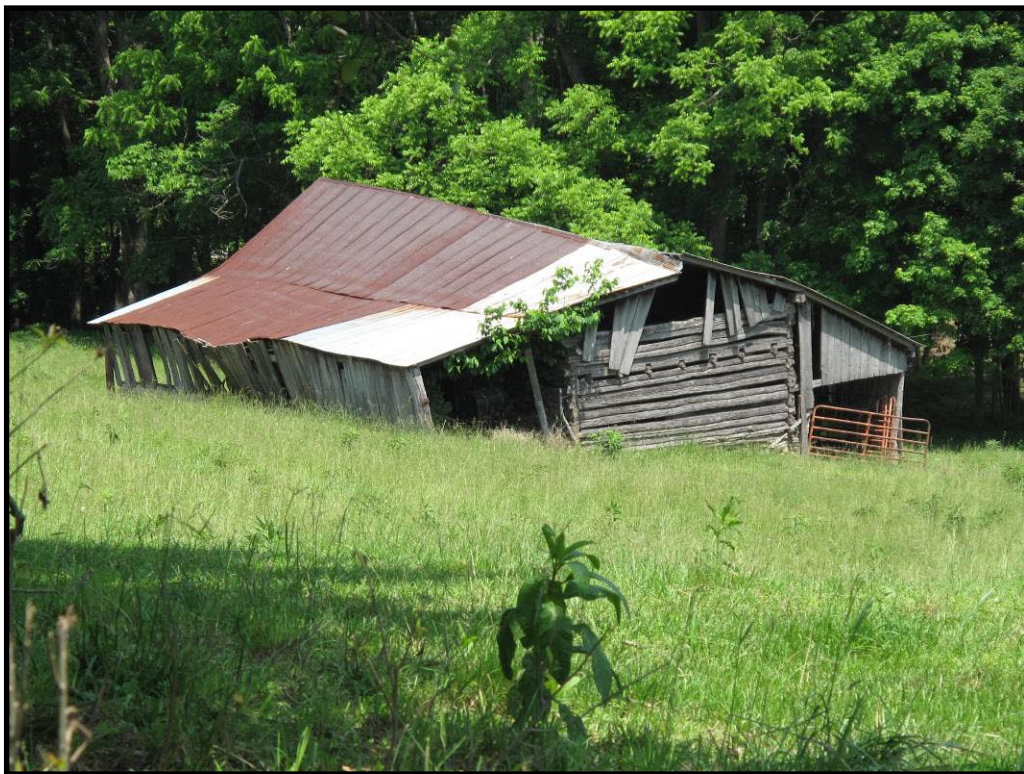
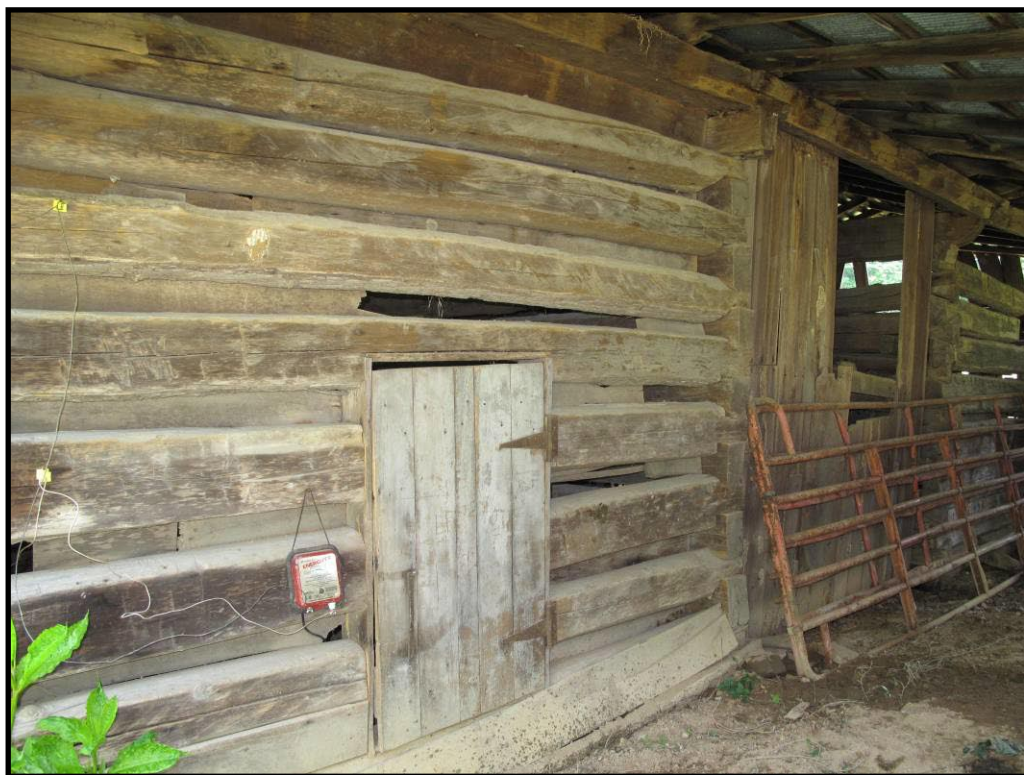
Figure 174 *Log crib barn, CS-101, Mintonville quad.*

Only one log crib was recorded in the survey area, CS-101, in the Mintonville quad. It is in poor condition. It consists of two log pens, square-notched, with a dogtrot area between, which has been filled in with vertical boards. Shed additions are located on the two long sides.

Figure 175 Log crib barn, CS-101, Mintonville quad.

Figure 176 Log crib barn, CS-101, Mintonville quad.
